Advanced Data Analysis (ADA) Solves the Mystery Why Two Challenging Sites have not Met Remedial Goals

Former Bob's Gulf Cleveland, TN (ID# 3-060017)

Old Hickory Citgo: Facility ID #8-570405 Jackson, TN

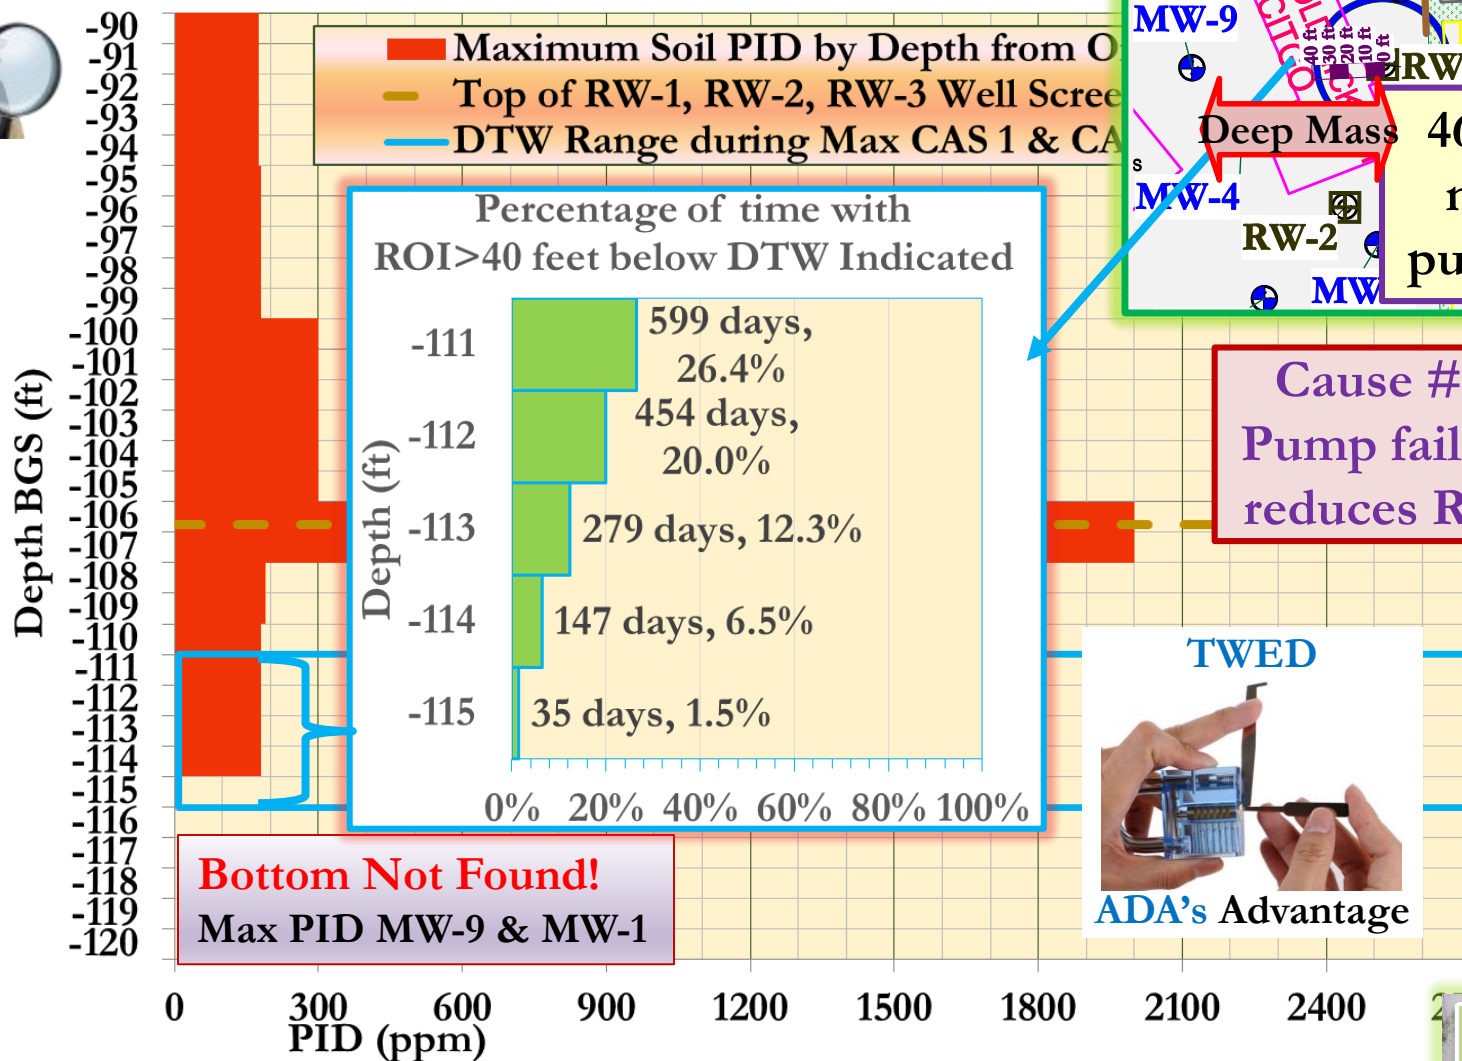
Maximum Soil PID by Depth from On-site Wells

SEE: Deeper Mass Indicated between RW-1 and MW-9 Not Frequently Exposed to Vapor Recovery: Incompletely Reduced Deeper Mass near RW-1 Possible

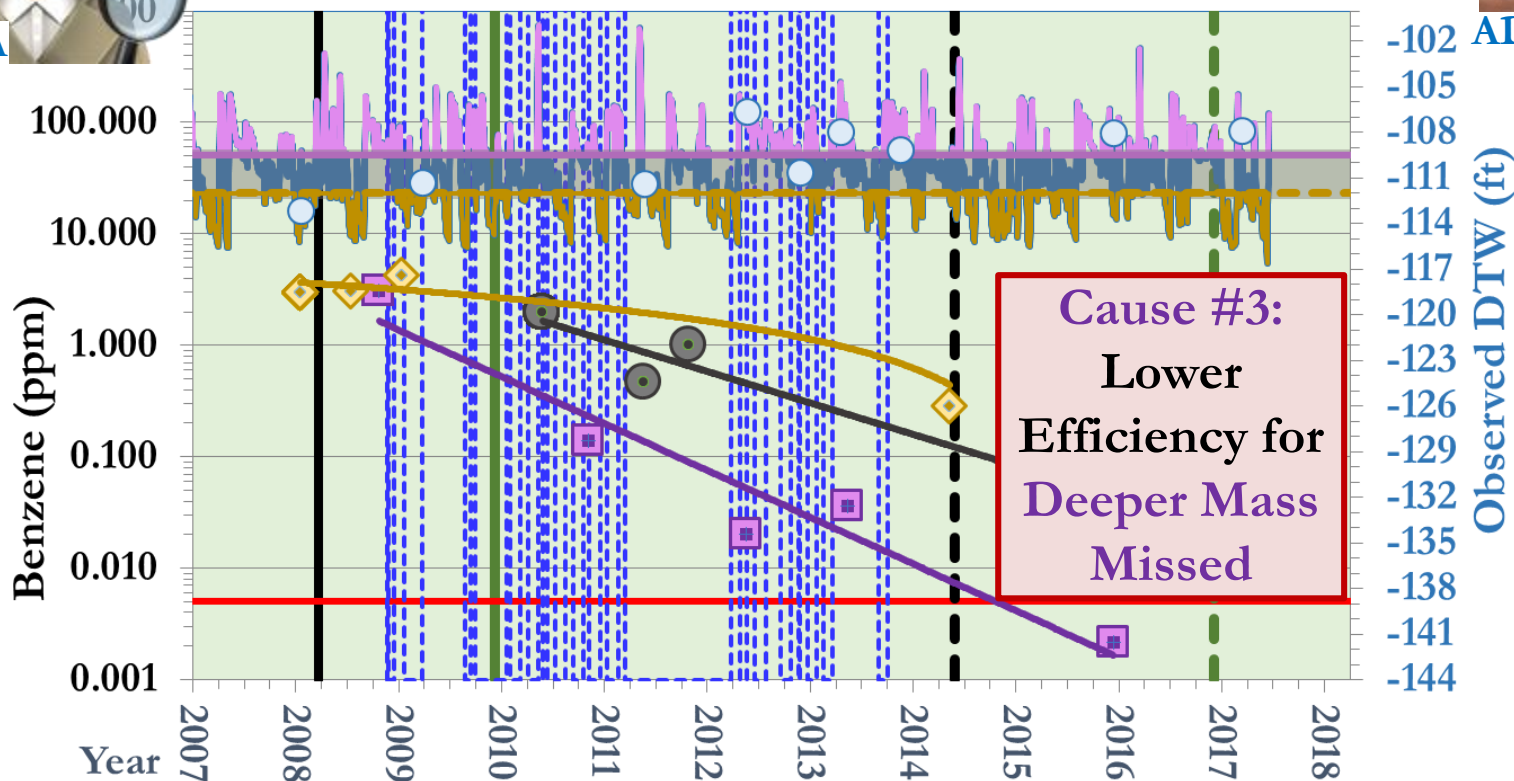
Benzene (ppm) at RW-1 Grouped by DTW

Can I find evidence of missed deep mass?
Will the concentrations rebound?

Yes!

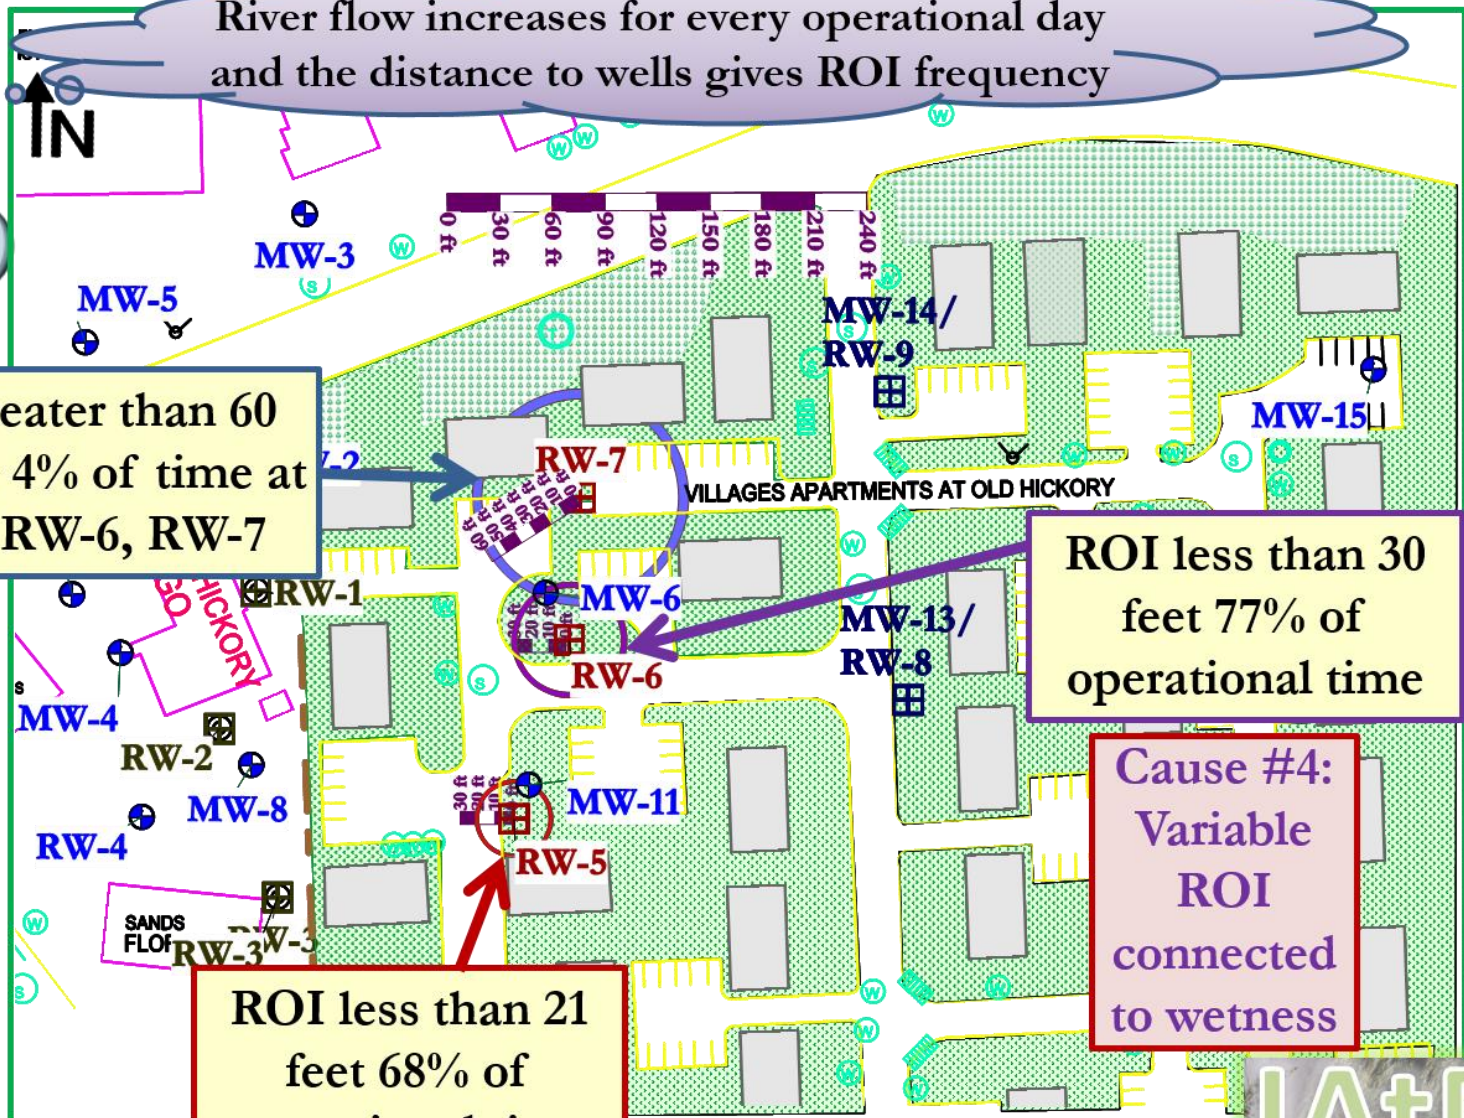
SEE: Frequency of Different ROIs for Off-site Recovery Wells Derived from Daily River Flow Data Shows Minimal Effective Off-site Vapor Recovery

ROI greater than 60 feet only 4% of time at RW-5, RW-6, RW-7

ROI less than 30 feet 77% of operational time

Cause #4:
Variable
ROI
connected
to wetness

ROI less than 21 feet 68% of operational time

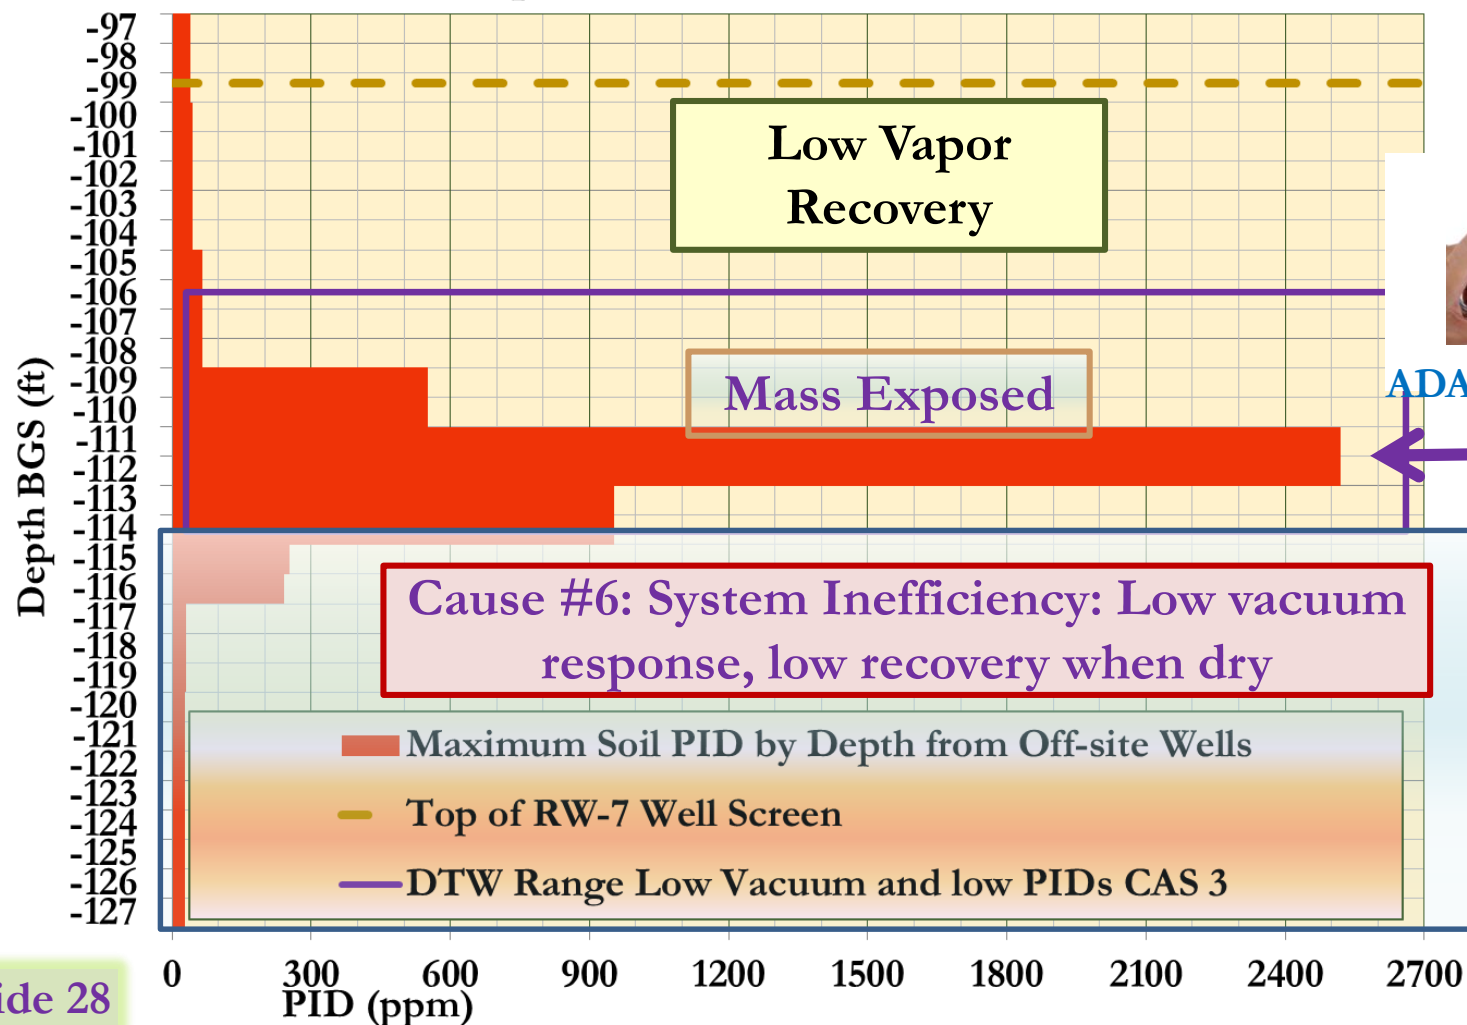
Maximum Soil PID by Depth from Off-site Wells

Why low vapor recovery when mass not submerged?

Low Vacuum Responses (small ROIs) with dry conditions

Small interval of high PIDs from recent release

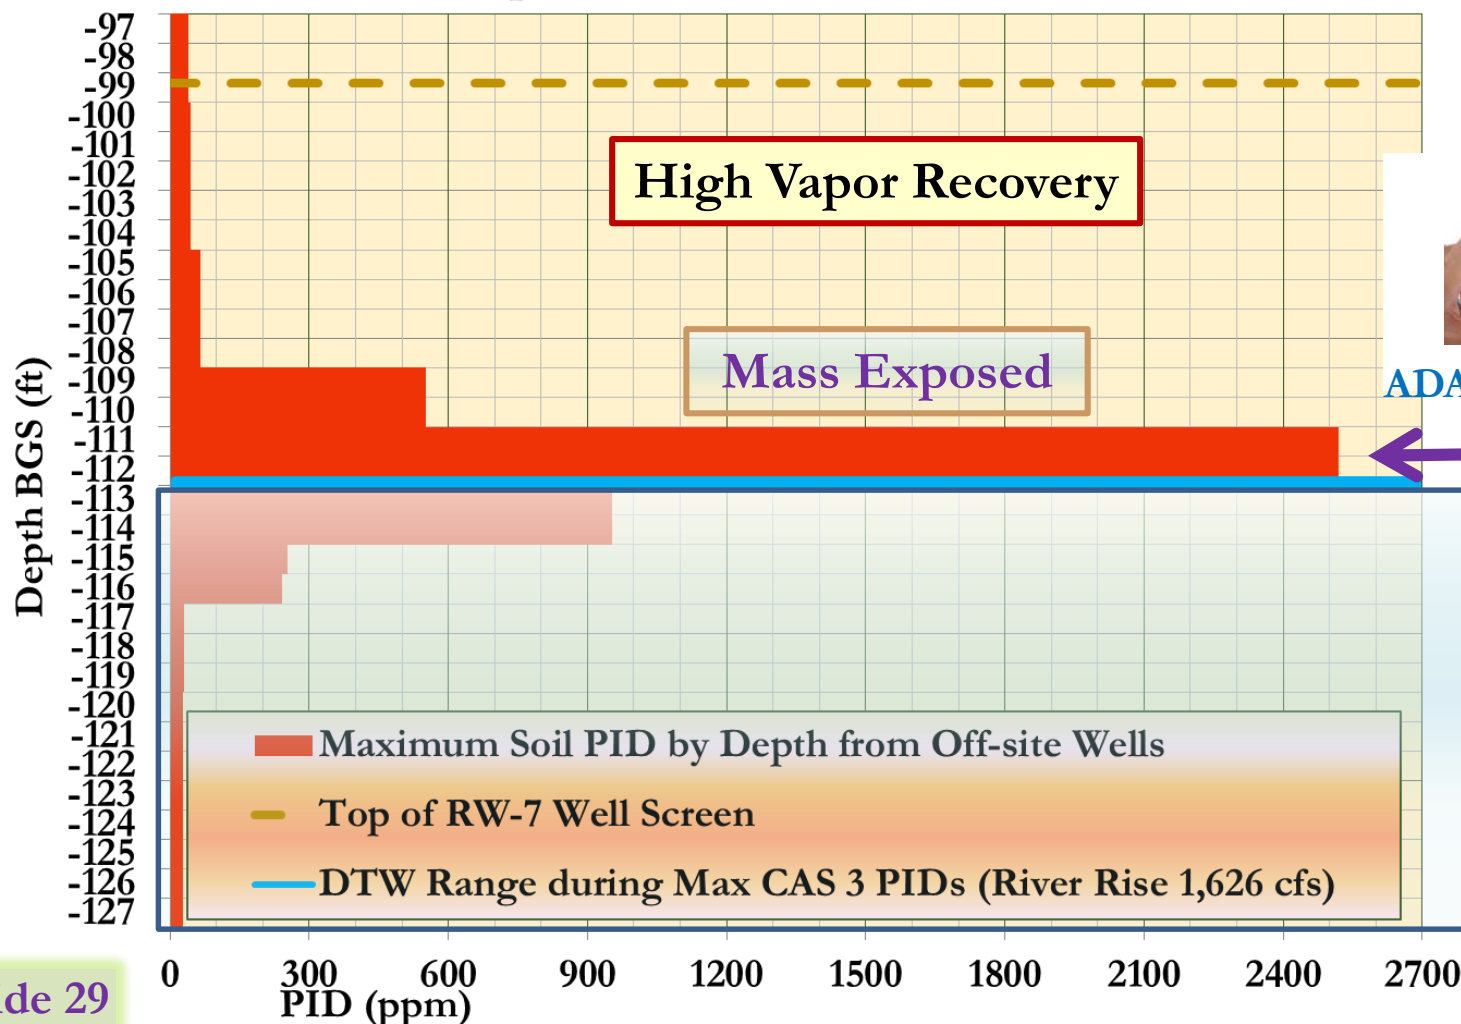
Maximum Soil PID by Depth from Off-site Wells

What cause the brief period of high vapor recovery?

High Vacuum Responses (large ROIs) with River Increases

Small interval of high PIDs from more recent release

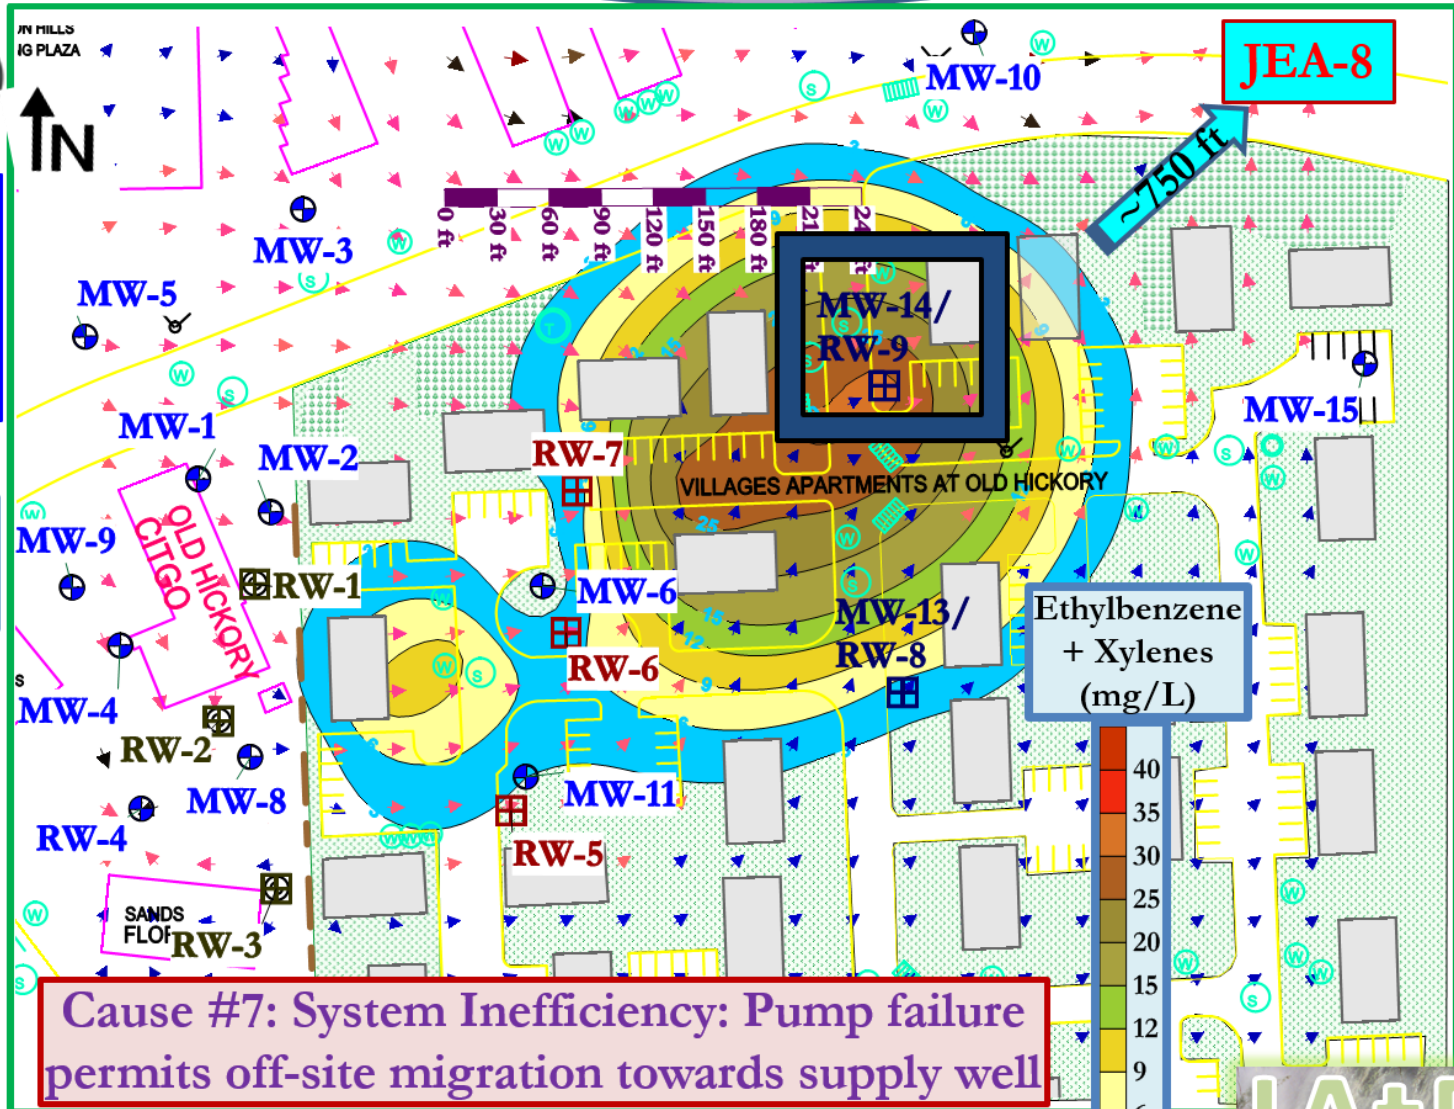
After 2015
No pump
flow
gradients

Cause #7: System Inefficiency: Pump failure
permits off-site migration towards supply well

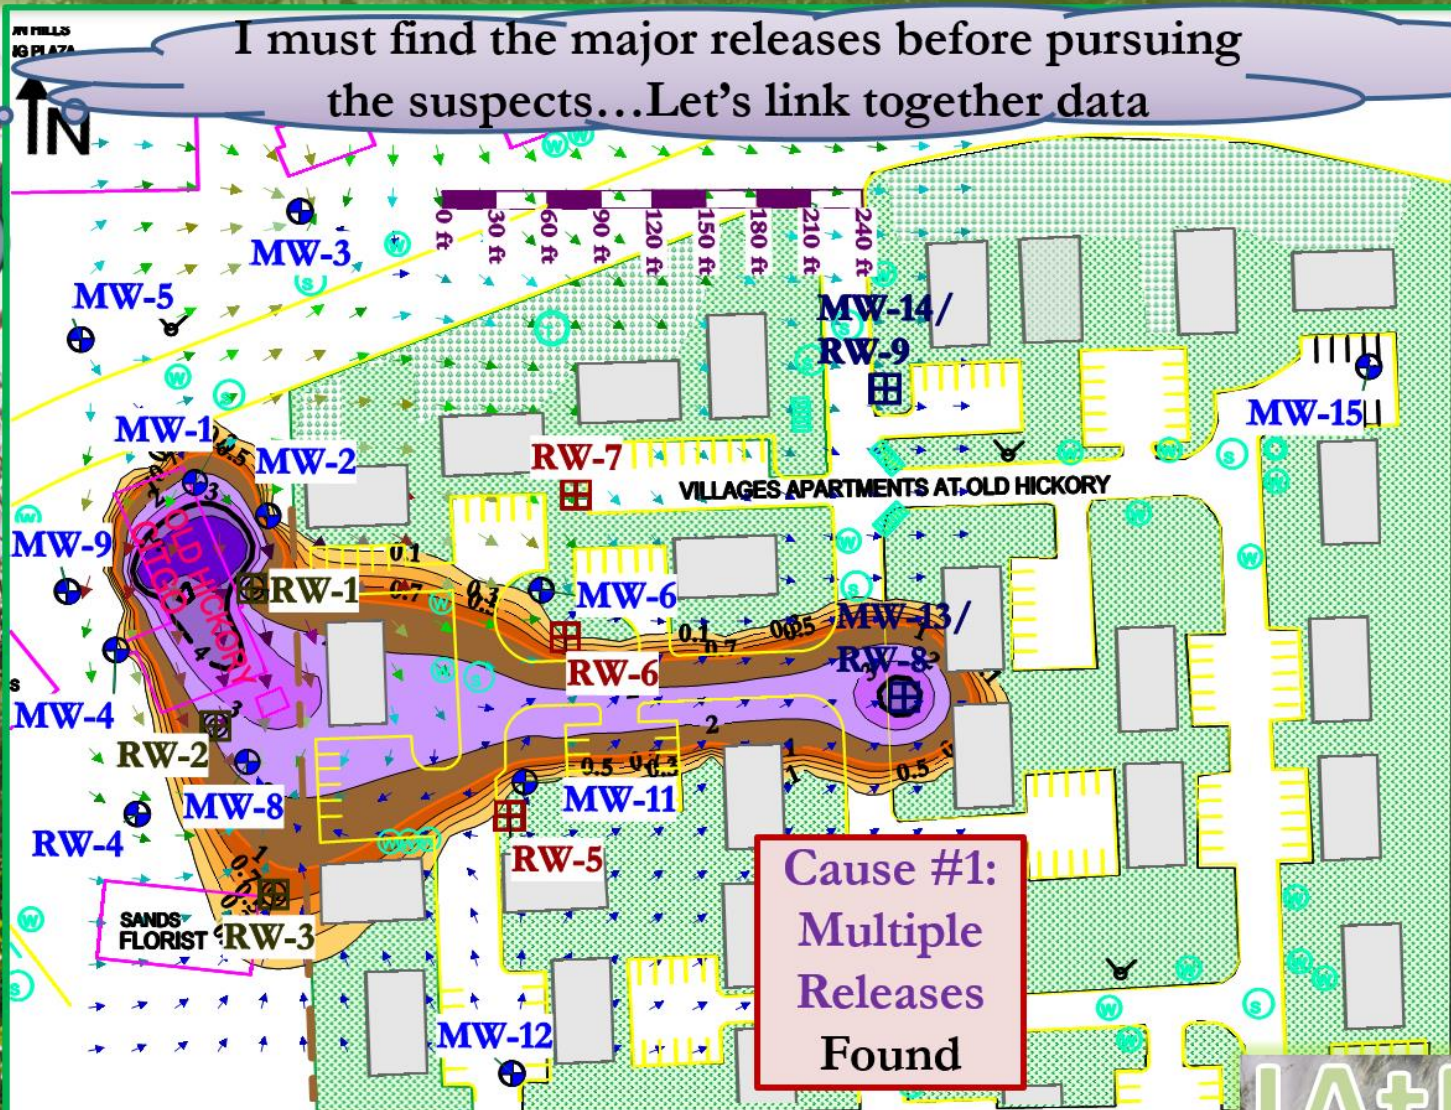
Cause #1:
Multiple
Releases
Found

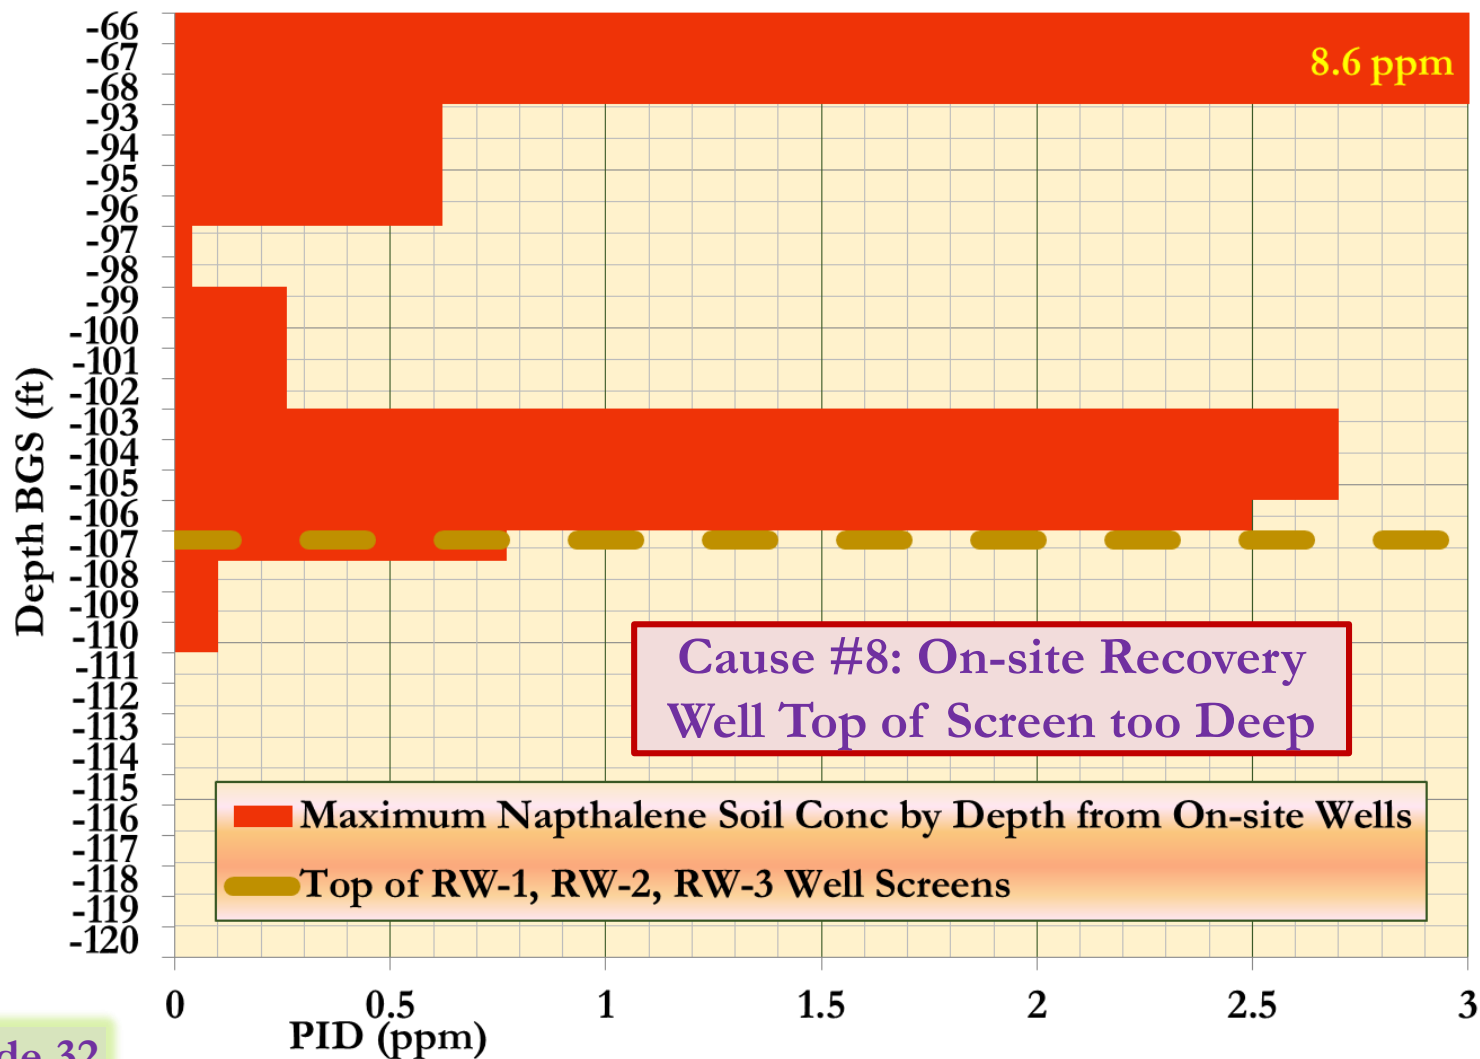
Maximum Naphthalene Soil Conc by Depth from On-site Wells

Why are Shallow Naphthalene Concentrations High at RW-1?
How is the Naphthalene profile different than the others?

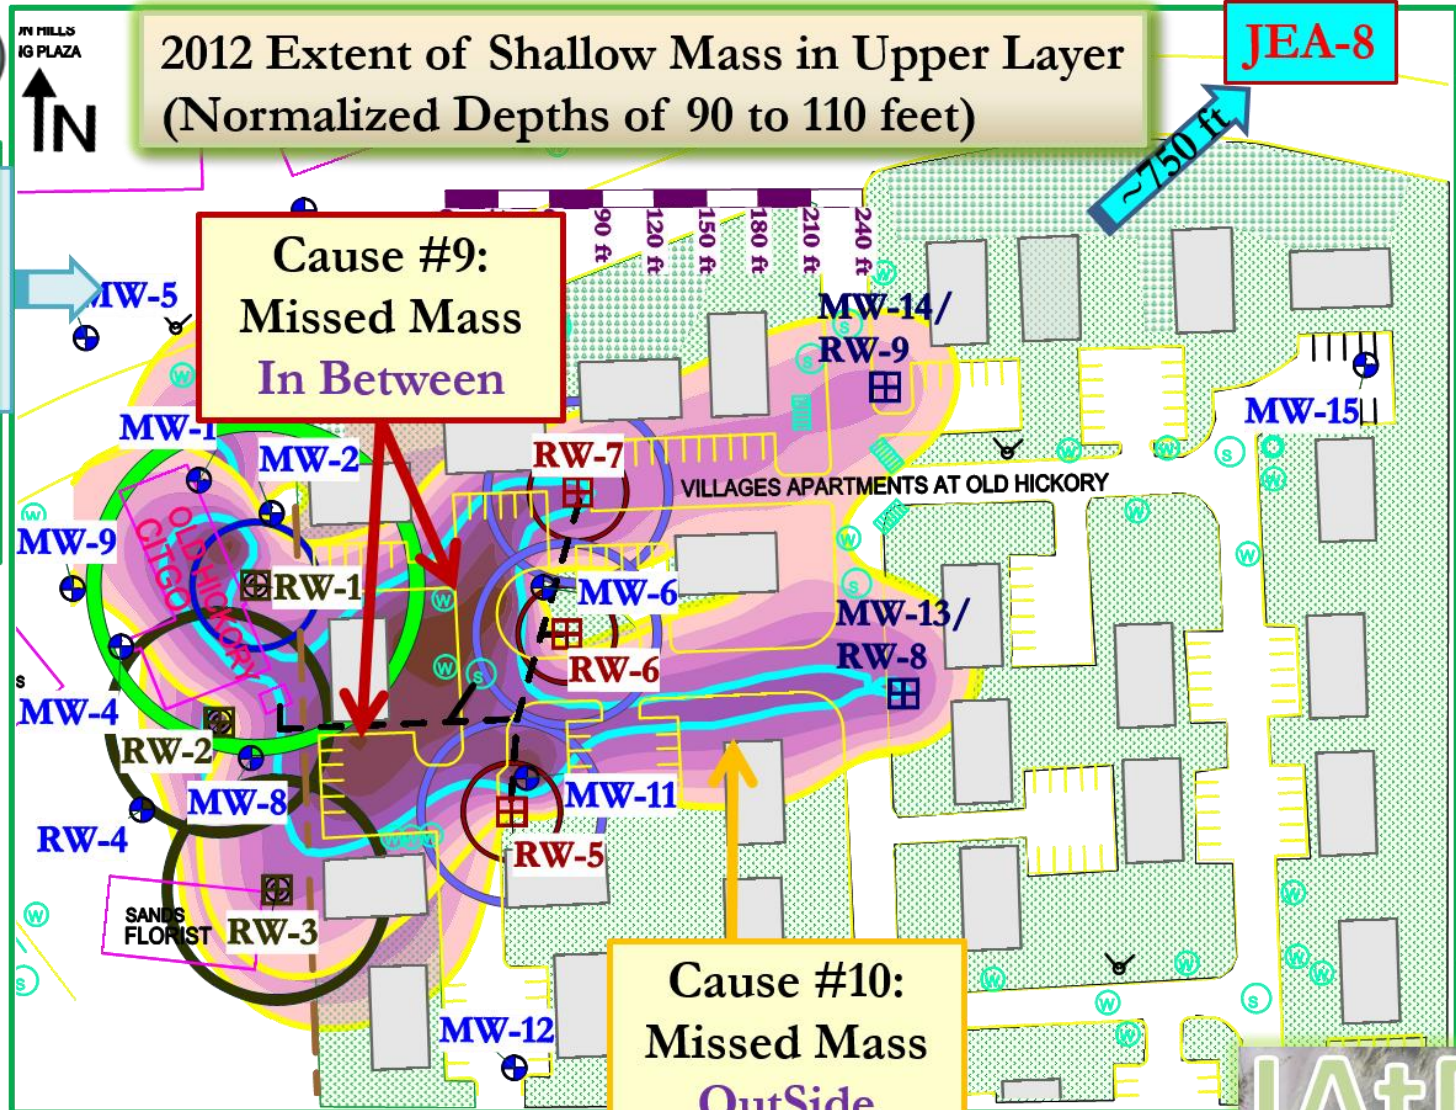
2012 Extent of Shallow Mass in Upper Layer
(Normalized Depths of 90 to 110 feet)

**Cause #9:
Missed Mass
In Between**

**Cause #10:
Missed Mass
OutSide**

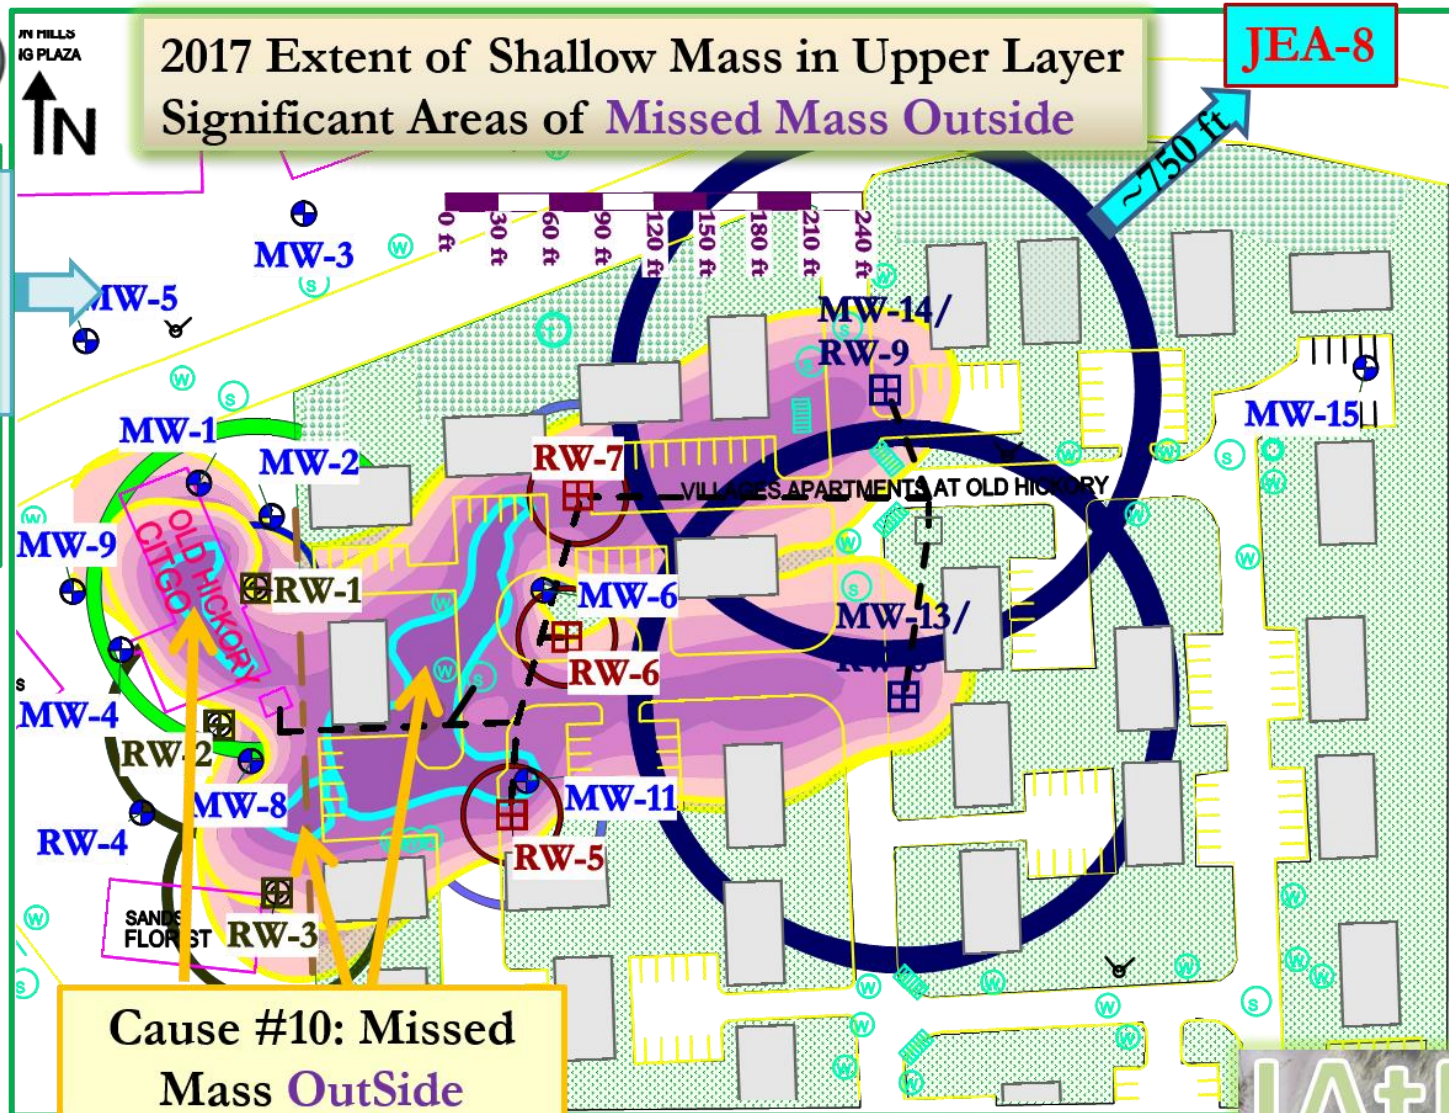
Cause #10: Missed Mass Outside (mostly naphthalene)

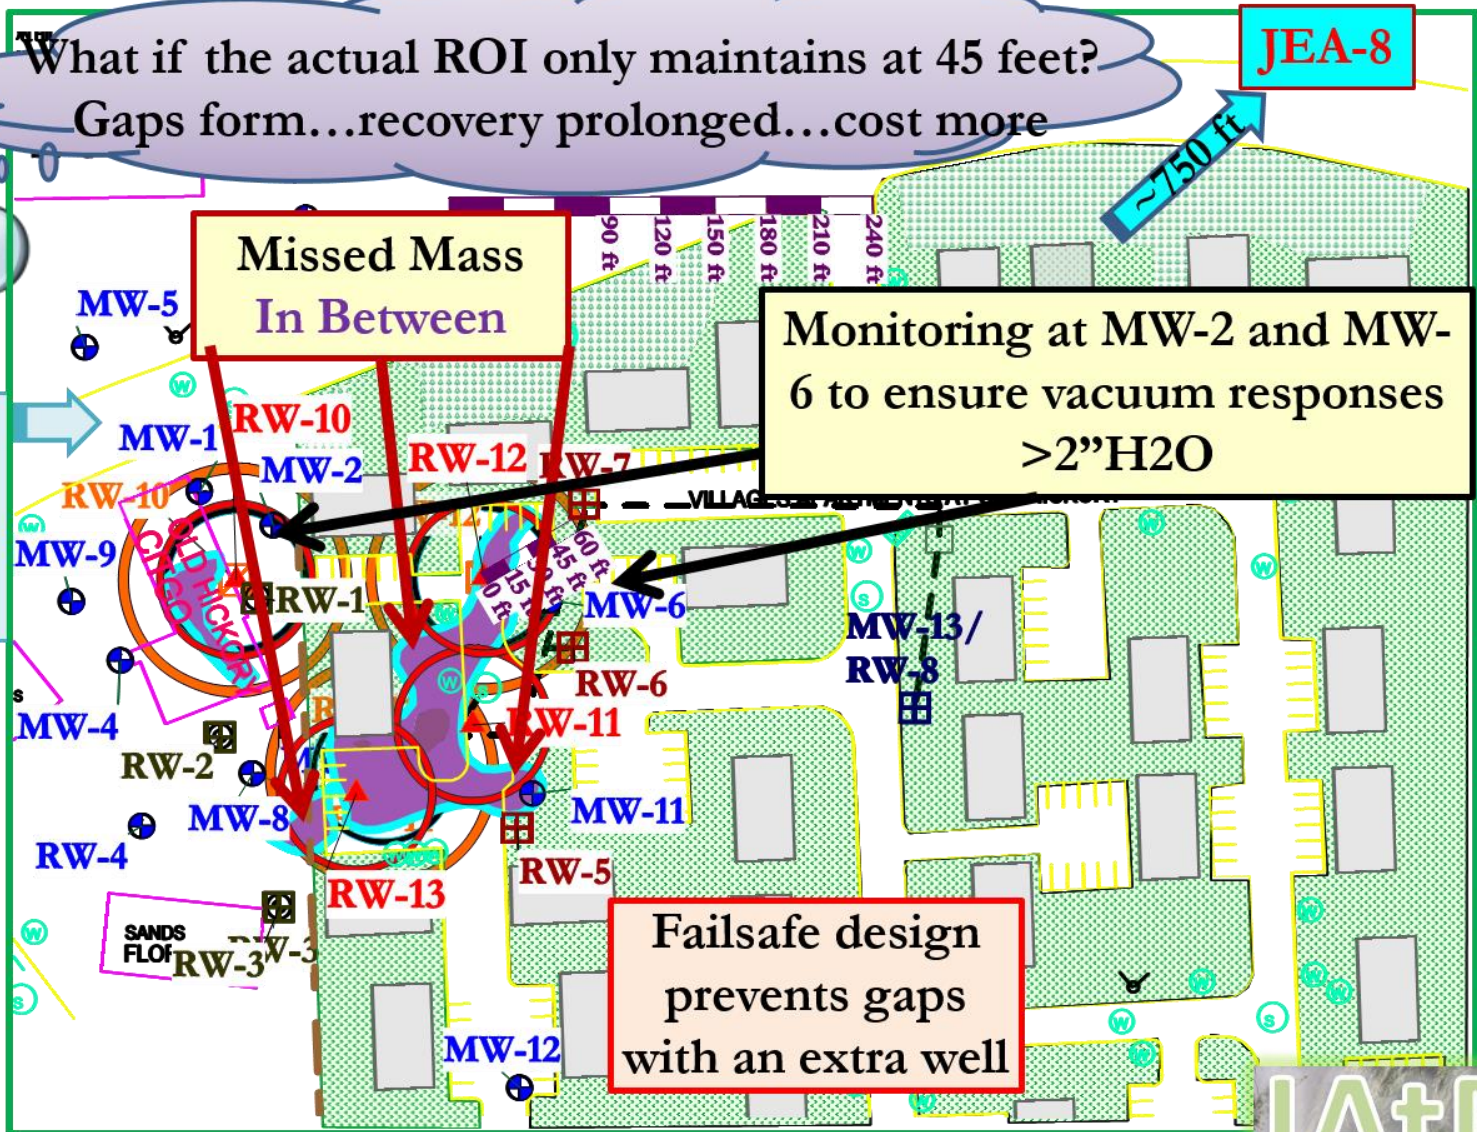
What if the actual ROI only maintains at 45 feet?
Gaps form...recovery prolonged...cost more

Necessary Suggestion: One On-site Recovery Well with Shallower Screen and Two Off-site Recovery Wells in Paved Areas Needed to Reduce Shallow Mass
